This case study is an edited version of Case Study 2 in *Operational Tube Failures in Heat Recovery Steam Generators: Metallurgical and Water Chemistry Perspectives* by Kevin J. Shields (formerly with STPA) and Ewa M. Labuda (of STPA), *Boiler & HRSG Tube Failures and Inspections*, November 2001.

Tube Failures in High Pressure Evaporator from Phosphate Gouging (Acid Phosphate Corrosion)

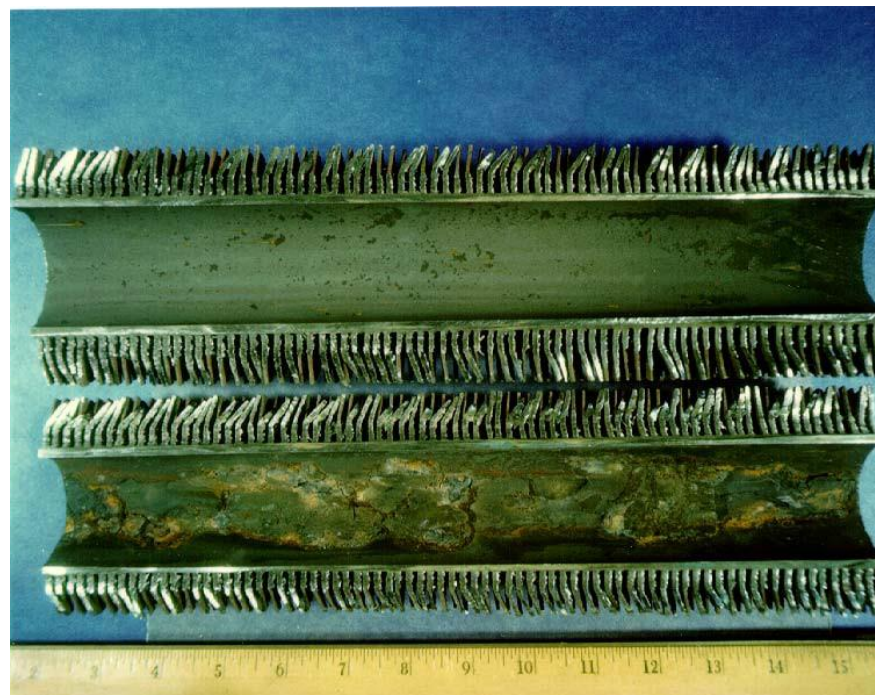
Figure 1 shows the inner diameter (ID) surface of the tube sample in the "as received" condition. The tube sample was split longitudinally into two halves arbitrarily labeled Side A and Side B. Side A exhibited a thick longitudinal band of deposit and corrosion products covering a severely gouged tube surface. In contrast, the ID surface of Side B was covered with a fairly even gray-black deposit. The thick accumulation on Side A exhibited orange material at its edge, possibly indicative of copper deposits. White material was observed in thin layers throughout the buildup; however, the bulk deposit was gray-black, indicative of magnetite (Figure 2).

Failed HP Evaporator Tube

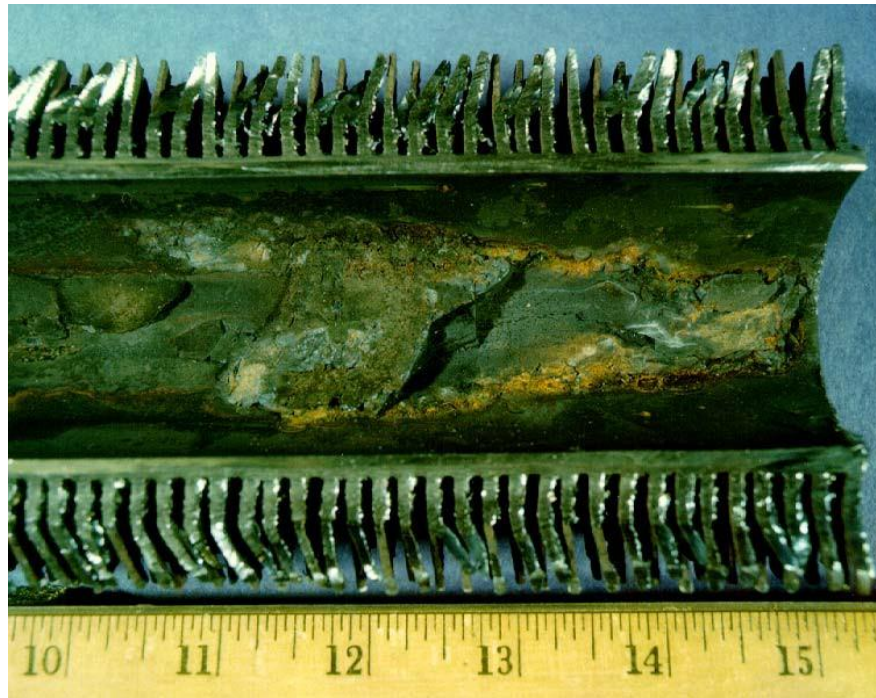
Figure 2

Close-up of Failure Location

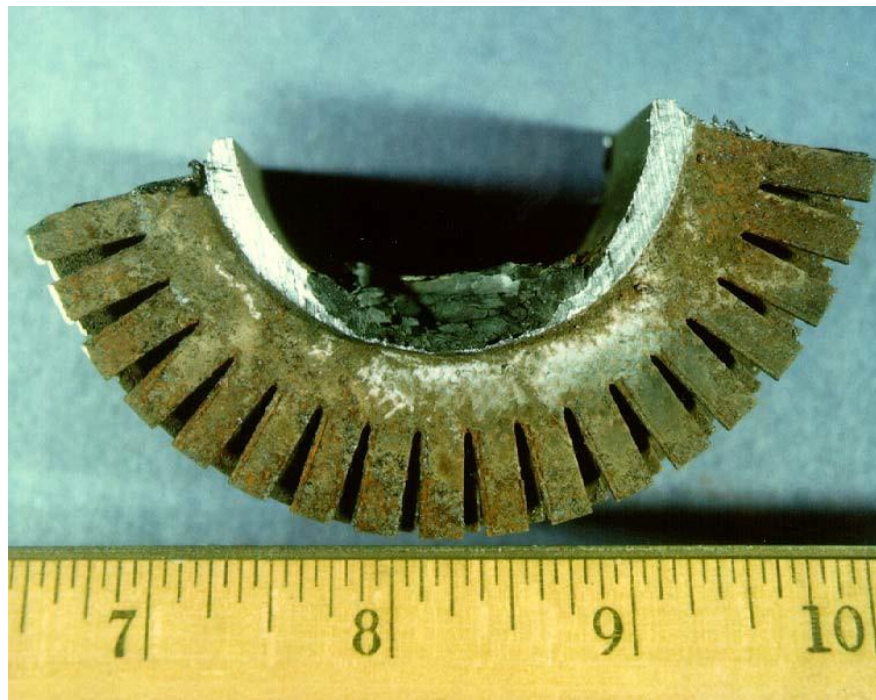
Figure 3

A transverse cross section through the tube wall on Side A at a gouge site is shown in Figure 3. The gouge penetrated 100% of the wall thickness beneath the thick accumulation of deposited material and corrosion products. Smaller gouges (not shown) exhibited a "bath tub" shape.

Cross-Sectional View of Corrosion Site
