# **Mechanical and Operating Problems with Deaerators**

ROBERT D. BARTHOLOMEW, P.E.  
Sheppard T. Powell Associates LLC  
Baltimore, MD

The paper provides examples of mechanical and operating problems with deaerators contributing to high dissolved oxygen and/or deaerator damage. Examples of mechanical problems presented include water entrainment in deaerator vent, failed baffles, erosion and flow accelerated corrosion (FAC) of deaerator vessel, too loose spray nozzles, too tight spray nozzles, leaking inlet water chamber, and failed trays. Detection and correction of the problems requires routine deaerator inspections.

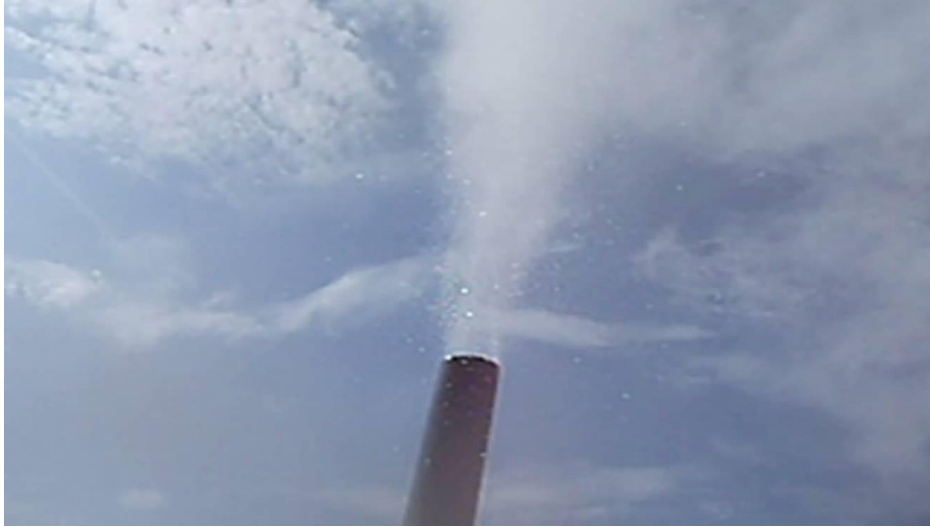
Figure 3 shows the vent plume from a deaerator at a power plant with 2000 psig boilers that had water entrainment in the deaerator vent. The boilers had copper alloys in the condensers and heaters and required dissolved oxygen levels <5 ppb and the feed of reducing agents (hydrazine). They also had a deaerating condenser, but sometimes they had leaks on the condensate pumps which severely tested the deaerator and contributed to high consumption rates of hydrazine and sometimes high feedwater dissolved oxygen levels. The amount of water droplets shown in the vent line was indicative of a possible problem with deaerator internals.

Figure 3: Example of Moderate Water Entrainment in Deaerator Vent

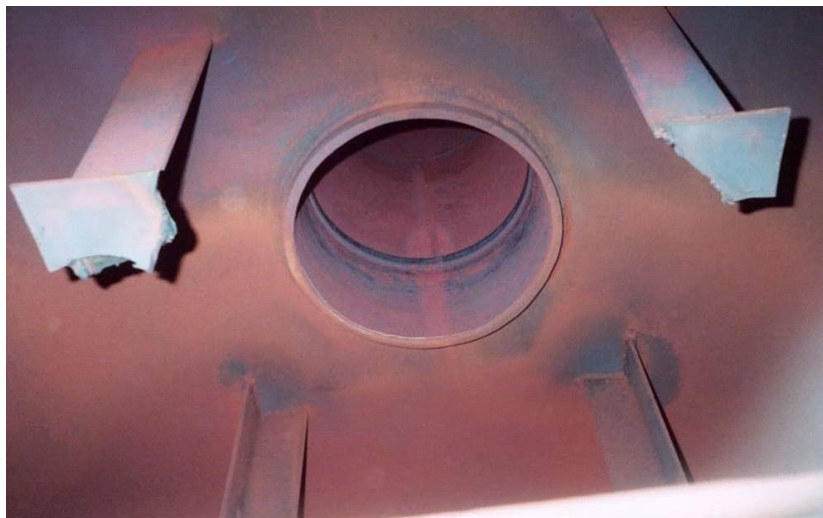
At this facility, there were several problems found in both deaerators that could have led to the water entrainment in the vents. In each deaerator, the inlet steam baffle was blown off its fittings (e.g., Figure 4) and the swing door (e.g., Figure 5) on the traybox was blown off the traybox at the steam inlet end. Figure 4 was photographed by looking out the traybox door in Photograph 5. During operation, it is likely that steam was blasting through the door, across the water sprays and some of the droplets from the water sprays were probably entrained up the vent lines.

Figure 4: Example of Failed Steam Inlet Baffle

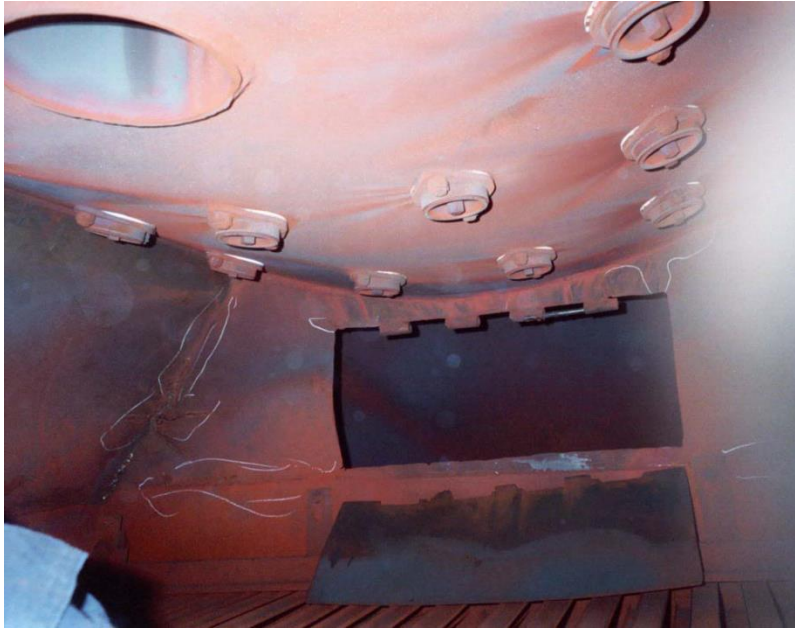
Also note the numerous cracks in the traybox wall in Photograph 5. This is a common problem with thin-wall stainless steel trayboxes. In some cases a crack may form and then stop without being repaired. Depending on the severity, history and success with past repairs, cracks may be welded or sections may be replaced. Cracks on various carbon steel supports underneath the traybox also are commonly experienced.

Figure 5: Example of Failed Traybox Door

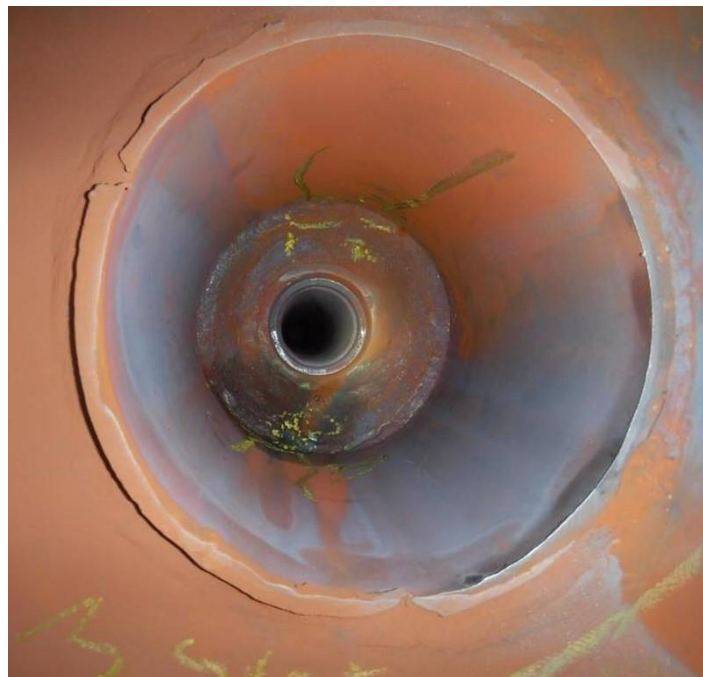
Initially, these deaerators had a problem with water spraying from leaks in the water inlet chest in similar locations as those in Figure 6. This area is viewed by lying on your back on the trays and looking up the vent pipes through the water inlet chest. The red areas are where oxygenated water leaks from the water inlet chest. Actually, there were two sister units and when we first inspected them, welding repairs were made in this area due to much more significant leaks than shown in Figure 6.

Figure 6: Example of Water Spraying From Water Inlet Chest Into Vent Offtakes

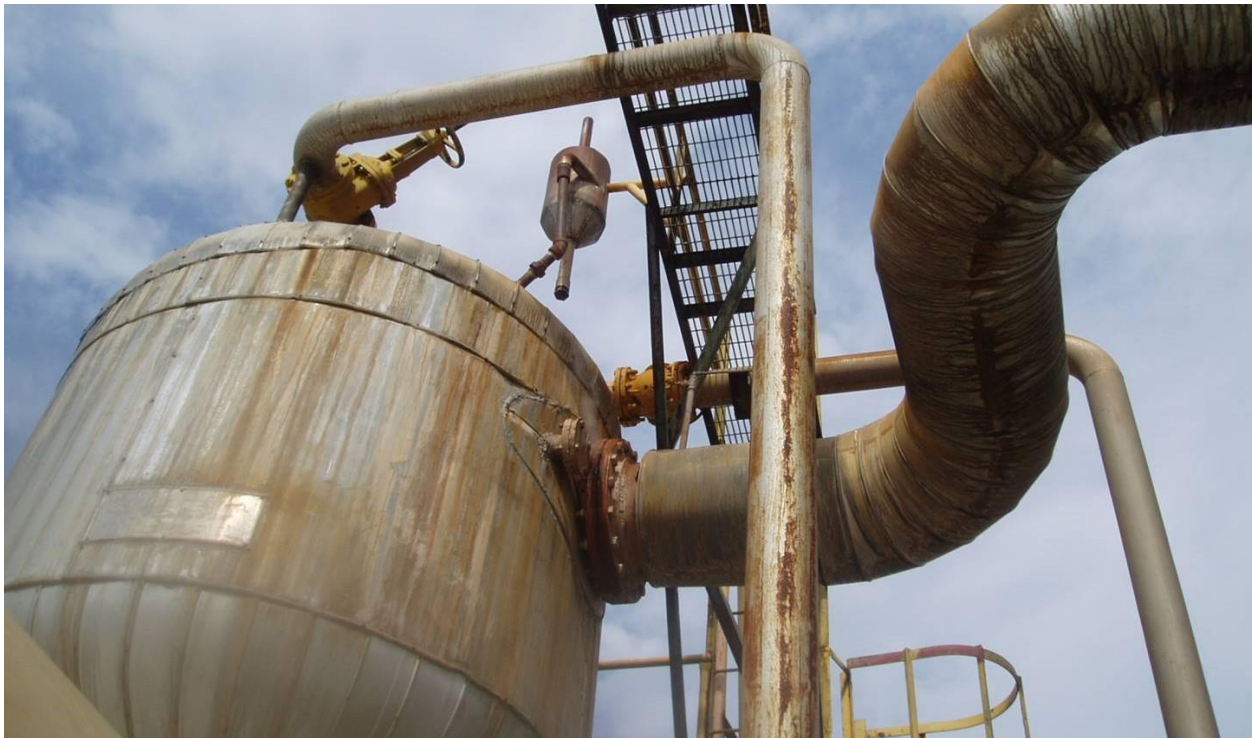
A second facility was at a pulp and paper mill with a 780-psig black liquor recovery boiler with demineralized makeup and a number of power boilers sharing a common deaerator. The deaerator was not made available for inspection during past routine boiler outages because they liked to keep at least one boiler operating. Figure 7 shows the exterior of the deaerator. It happens to be not running at the moment, but we did not get a chance to actually inspect the deaerator. No information on the deaerator design was available. At some point, a cyclone separator had been installed on the deaerator vent line (above and to the right of the deaerator heater section) in response to the amount of water flowing out the vent during operation.

Figure 7: Deaerator Vent with Cyclone Separator on Vent

When this deaerator ran, before internal repairs, there was a continuous stream of water out the bottom of the separator and steam out the top. The deaerator had horrible performance. Despite a high feed of sodium sulfite, they obviously were not able to consistently control dissolved oxygen and severe dissolved oxygen corrosion occurred in the economizer inlet tubes during operation. They were not monitoring feedwater dissolved oxygen prior to our review. Sulfite consumption indicated a feedwater oxygen level of 344 ppb  $O_2$ . Figure 8 shows the dissolved oxygen tubercles which formed in the entrance off the economizer inlet header in the first pass economizer tubes. The economizer tubes in this unit were vertical.

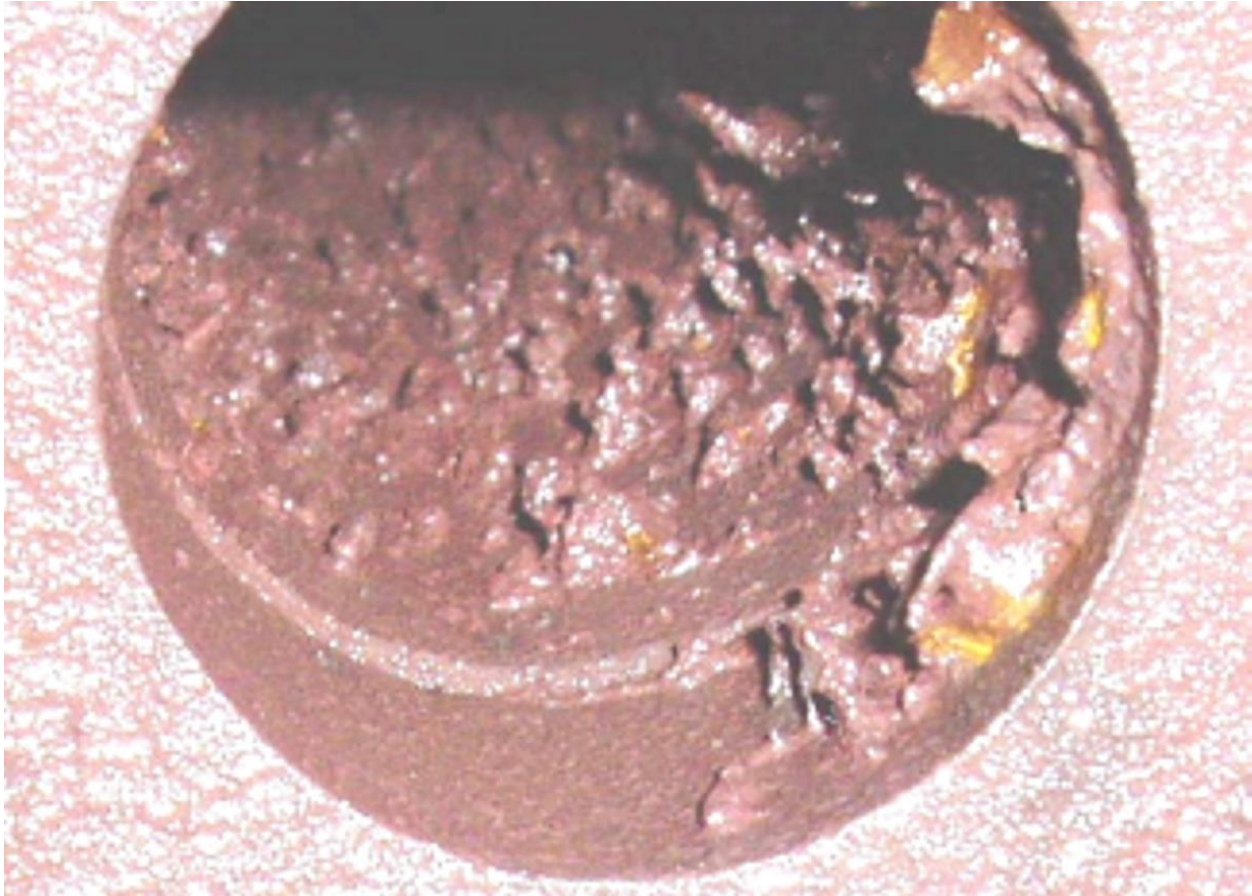
Figure 8: In-service Oxygen Pitting in Economizer Tube

Incidentally, this economizer was chemically cleaned and passivated, the 1-inch diameter carbon steel sample lines for feedwater were replaced with stainless steel tubing, dissolved oxygen analyzers were installed on the feedwater, the deaerator was repaired (again, details were not available), and – reportedly – control of the feedwater dissolved oxygen was achieved for at least a while.

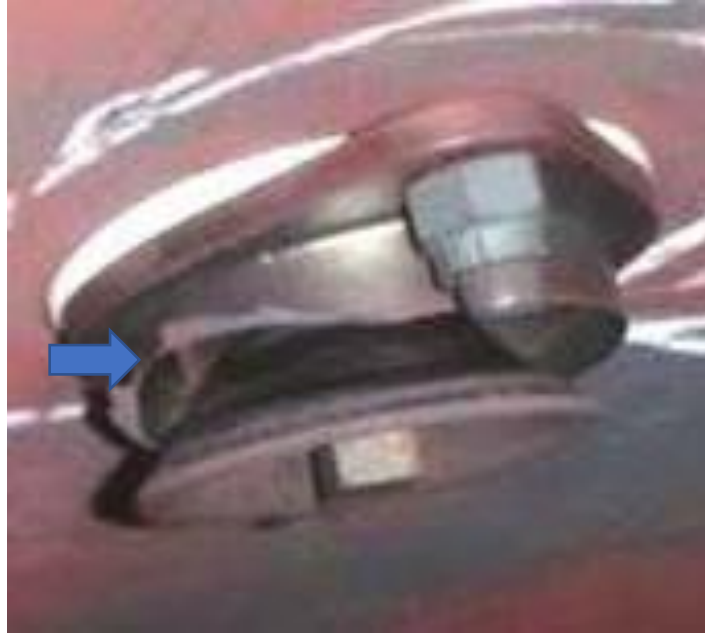
Figure 9 shows a nozzle (circular plate in middle) and seat after the first year of operation of a new deaerator. The plant elected to install the spray nozzles themselves rather than pay to have the deaerator manufacturer install them and all of the nozzles were too tight. The plant had just installed the spray nozzles without adjustment as they were received from the manufacturer. Operators reported that the deaerator made a chattering noise when it operated. The nozzles were so tight that the nozzles had to push open let some water out and then slam shut. Pushing the water through a compressed orifice eroded the side of the nozzle seat. Eventually, the springs probably failed from high cycle fatigue. Thus, not only was the seat eaten out (see blue arrow), but the nozzle failed. During an inspection also check that the seats are firmly attached to the inlet chamber.

Figure 9: Example of Eroded Seats Due to Nozzles Being Too Tight

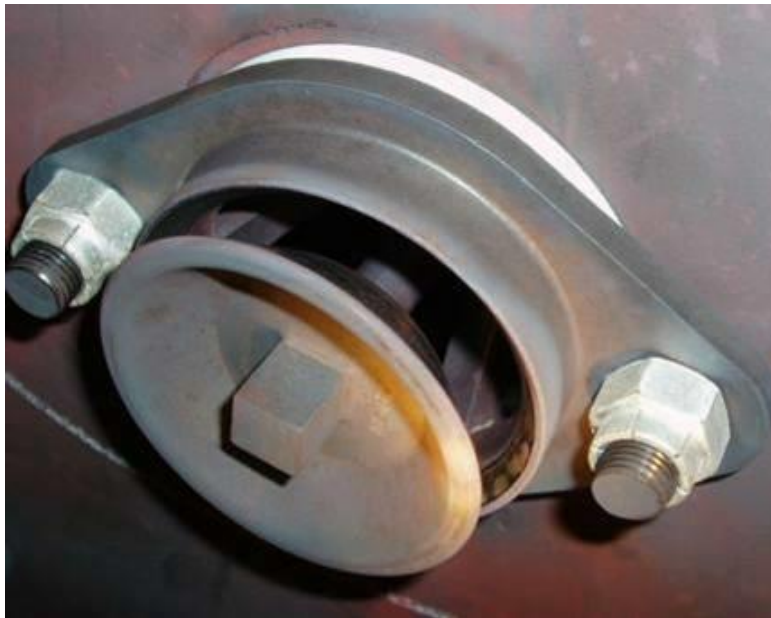
A more common problem in operating deaerators is loose (Figure 10) or failed nozzles. During routine inspections, it is standard inspection practice to snap (pull down and release) each nozzle and ensure that they have similar spring tensions. Over a number of years of operation, some nozzles will no longer reseat flush or snap back as firmly. This is attributed to spring deformation. When this occurs the nozzle should be replaced as you need a water spray of small droplets not a deluge of water flowing through a few nozzles.

Figure 10: Loose/Deformed Spring

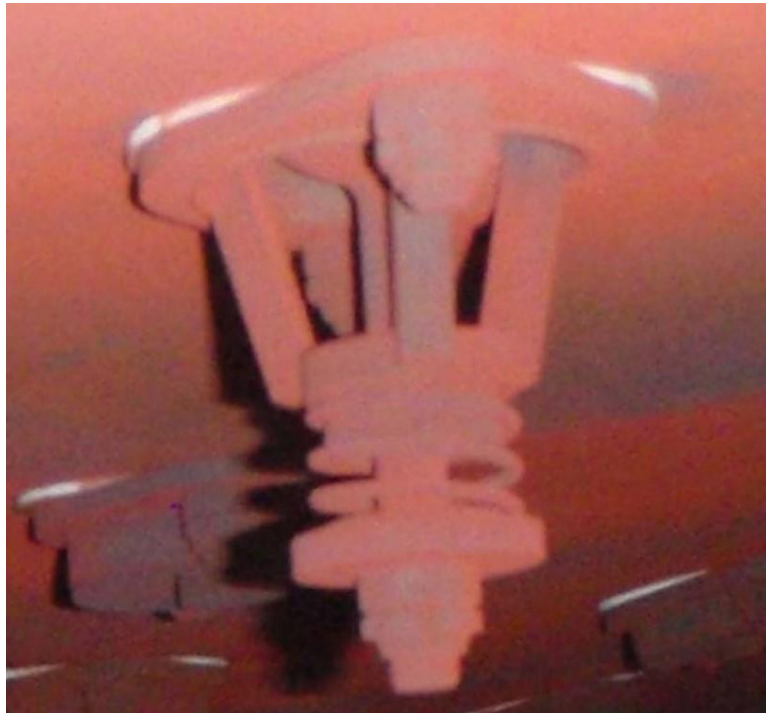
Following a collapse of the inlet water chest at some facilities, a small proportion of the spray nozzles were inverted (Figure 11) to relieve the pressure differential across the inlet water chest during a trip. It is cautioned that you should not invert more than a few percent of the nozzles because when you invert a nozzle you increase the water flow that needs to go through the remaining nozzles. If you are nozzle limited, it may be preferable to increase the total number of nozzles in order to install a few additional inverted nozzles rather than invert the nozzles you have.

Figure 11: Inverted Nozzles

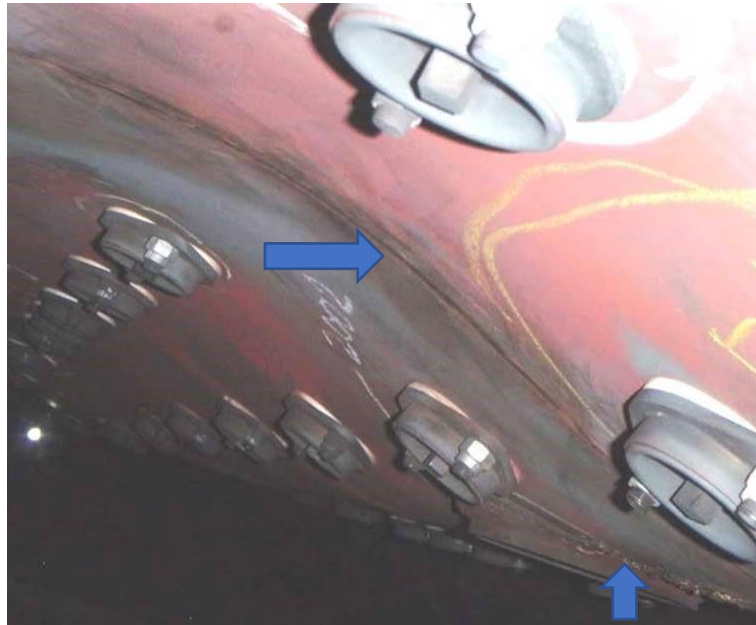
Figure 12 shows an example of a failed inlet water chest within the traybox. This chest had failed on a number of occasions and was repaired by welding (see blue arrows). Inverting a few nozzles seemed to alleviate the problem. Deaerator manufacturers have sturdier designs of water inlet chests that are based on thick wall pipes rather than thin wall stainless chambers. An example is provided later in this presentation.

Figure 12: Failed Inlet Water Chest

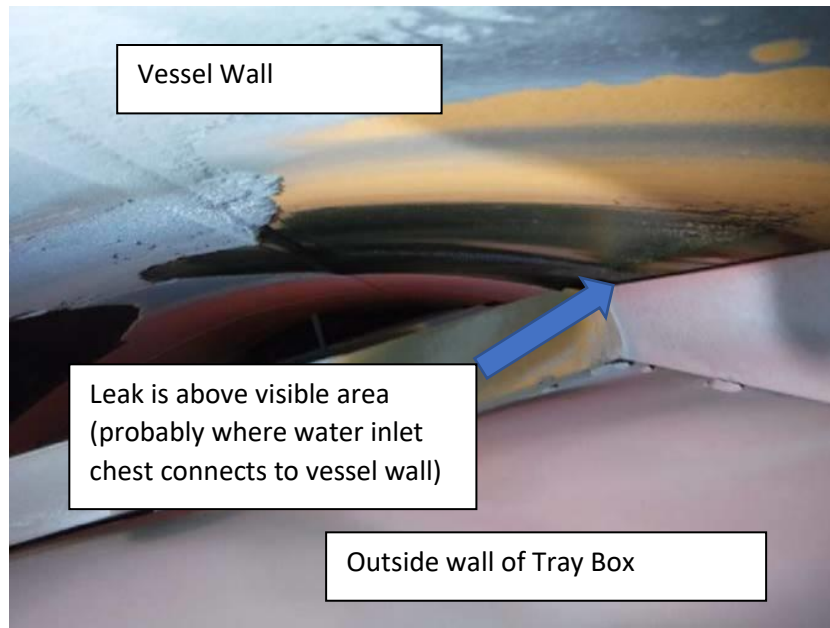
Figure 13 shows a more problematic type of failure of the inlet water chest. The water inlet chest was torn and was spraying outside of the traybox. The top of the deaerator is the right side of the photograph, the traybox exterior is the bottom of the photograph and the wall of the vessel is the top of the photograph. The cold inlet water was spraying along the vessel wall. Inlet steam is drawn to the cold water and flow accelerated corrosion (FAC) of the wall occurs. No oxygen scavengers had been fed for years and the deaerator vents are usually kept closed because the inlet and feedwater oxygen levels do not require venting to achieve their feedwater dissolved oxygen limits. This type of failure is much less common.

Figure 13: FAC of Wall from Failed Inlet Water Chest

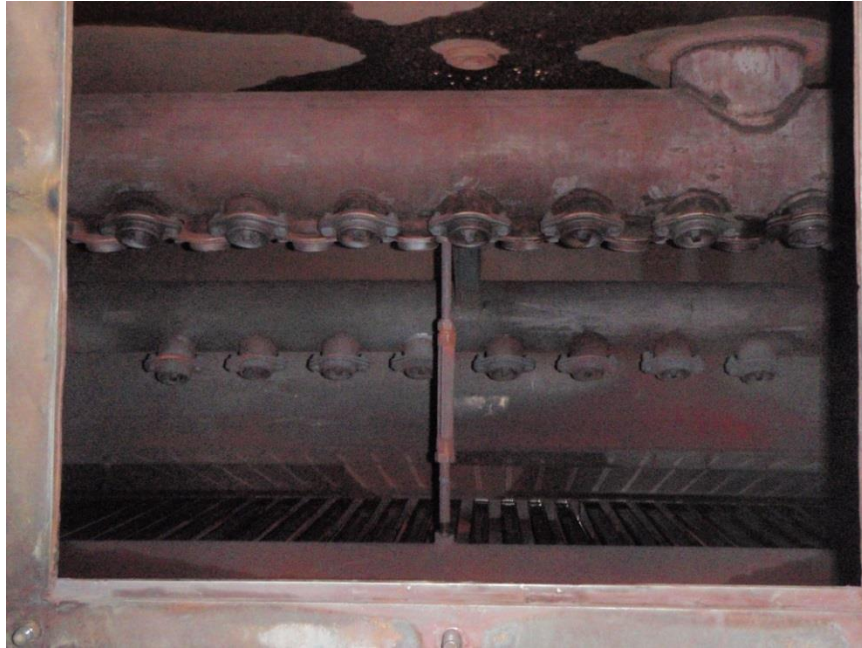
Figure 14 shows an example of a deaerator for a 1250 psig sawdust fired boiler at a pulp mill that has two separate pipe style spray headers. One header receives condensate and the other spray header receives demineralized makeup. The pipe style of spray headers is much sturdier than the water inlet chest design and inverted nozzles are not required for these spray headers. However, we have seen a discussion that suggested that the stainless steel pipes going through the water inlet chest may serve as a partial vent condenser. Thus, before changing the water inlet header design consult a deaerator manufacturer to determine if other changes may be required.

Figure 14: Dual Pipe Inlet Water Distributors

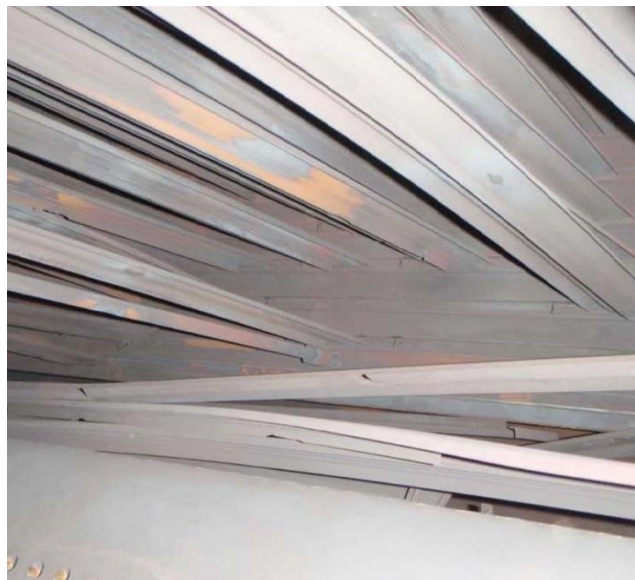
some of the deaerators installed in the 1950s, had tracks on the sides of the traybox and long, narrow trays were fed into the tracks. These had systemic problems of tray failures. Figure 15 shows an example of one of these 40-year old deaerators with numerous failed trays.

Figure 15: Failed Single Trays

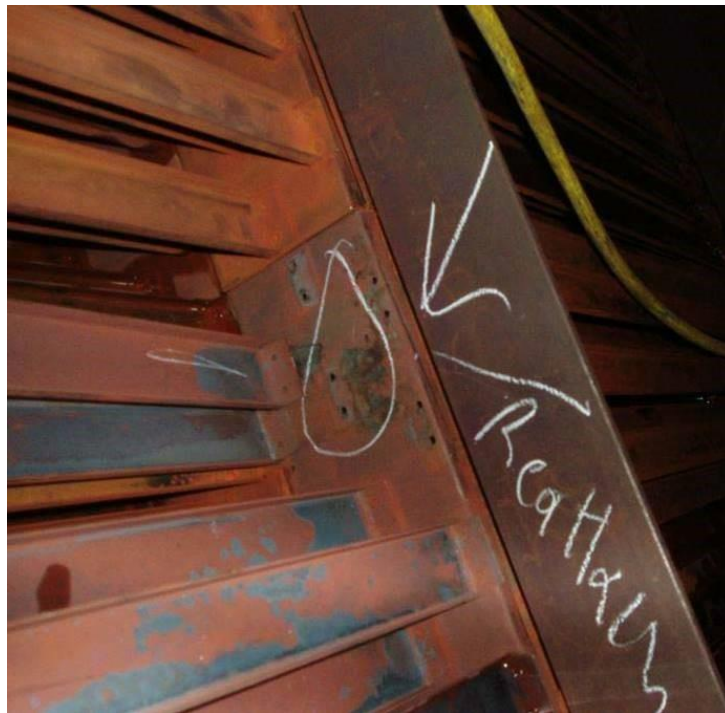
In modern deaerator designs, the trays are usually either in riveted bundles or much bigger and more firmly supported. In the power industry, the trays usually consist of bundles of small stainless steel trays. These are fairly sturdy, but top trays within the bundles can snap off (Figure 16) as a result of large personnel working in the tray section to effect repairs on spray nozzles. If it is just a couple of trays within one bundle, it is not expected to have a significant effect or require immediate repair. In this case, it is my recollection that the welder attempted to temporarily tack-weld the riveted trays in place. However, this is thin wall stainless and replacement of the affected tray bundle is more expeditious. These modern tray bundles are usually very well supported and a significant failure of the trays is rare. In modern spray/tray designs, there are usually vertical stays and horizontal hold-down braces on top and steel grating under the trays.

Figure 16: Snapped Top Trays.

Routine maintenance for trays typically just consists of basically ensuring all of this hardware is in place. Standard hardware includes the horizontal holddown braces (shown on top of the trays in Figure 16) and vertical stays that are used to align the tray bundles (not shown). When not fully in place the tray bundles can lift and become misaligned.

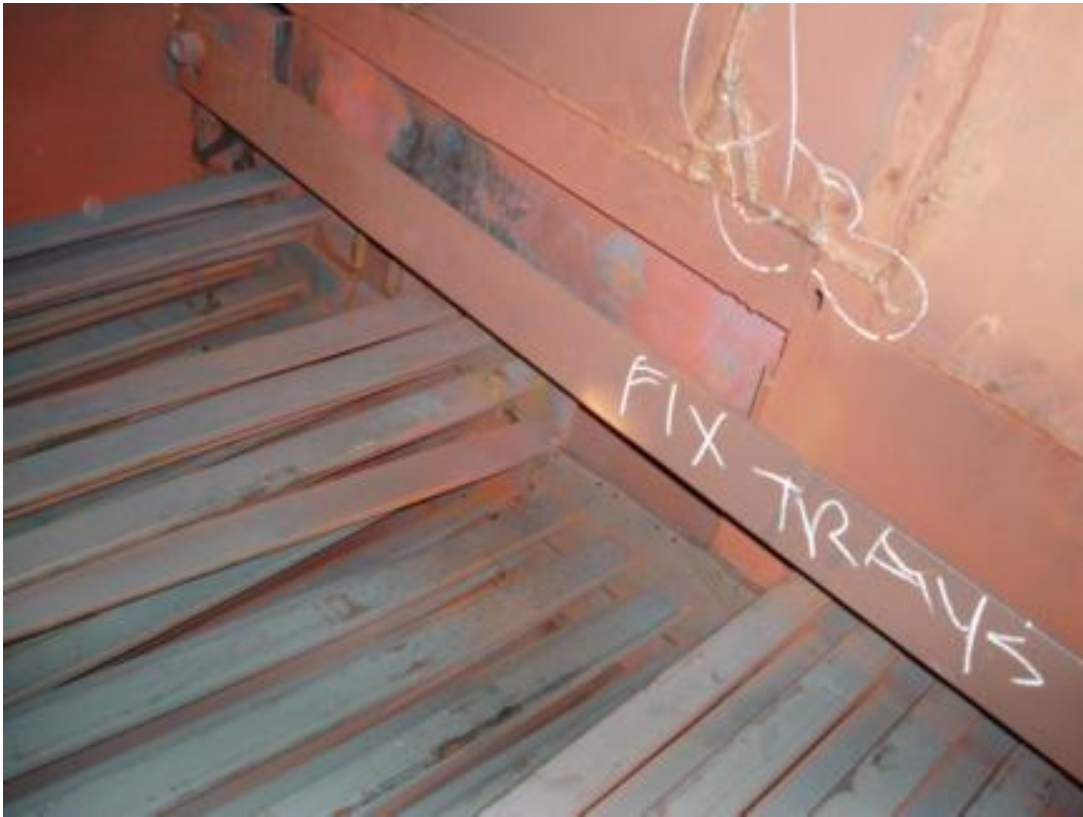
There have been a few cases where a partial collapse occurred and removal and realignment and partial replacement of a number of bundles was required – as shown in Figure 17. More important than the fact that two separate bundles had slipped down off the supports, all of the tray bundles in Figure 17 were upside down. The concave side was facing down rather than up. Standard designs have the trays installed such that they retain water to maximize the time for deaeration in the tray zone.

Figure 17: Complete Bundle Removal Required

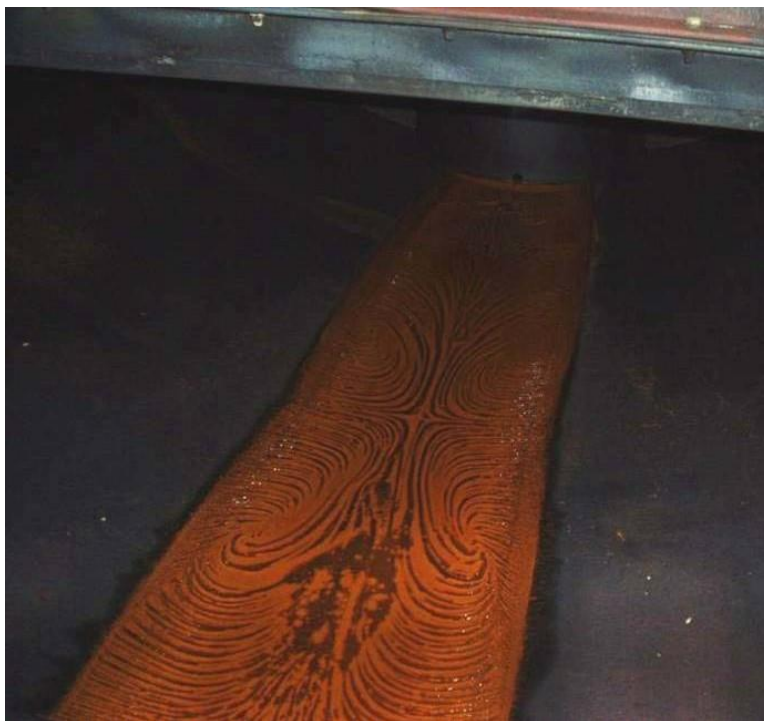
A common problem in high-pressure, all-steel power boiler cycles relying on ammonia for feedwater pH control is flow accelerated corrosion (FAC) of the floor. In some cases the erosive forces are great enough that erosion rather than FAC occurs. Figure 18 shows an example of erosion of a deaerator floor and Figure 19 shows an example of FAC of the deaerator floor. The chemistry program was subsequently changed to raise the ammonia and pH and to change from a reducing program to a slightly oxidizing treatment program to reduce FAC, in the unit. While the changes reduced FAC in the storage tank and other areas it did not seem to result in passivation of this area. The deaerator manufacturer installed baffles on the sides of the equalization lines to raise the water level on the floor. This had no effect on the attack. Allowing the door on the traybox to swing freely and operating at lower load (due to lower power demand) appeared to correspond with reduced erosion and FAC. In some subsequent outages, the steam erosion appeared to have nearly ceased, only to be noted again in a subsequent outage. Thus, it is expected that the erosion in this deaerator was related more to load than to any other factor.

Figure 18: Erosion of Deaerator Floor

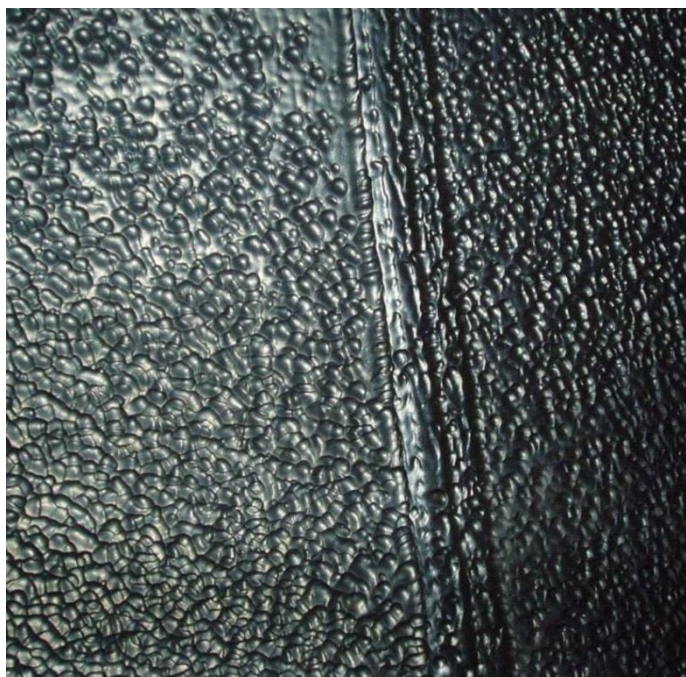
Figure 19: FAC of Same Deaerator Floor Beyond Eroded Area

the tray support system. At least periodically, beneath the traybox should be inspected for damage to the grating and support structure. Replacement grating should be P22 or stainless steel to minimize subsequent damage from FAC.
